CORROCOAT NEWS

LONG TERM PROTECTION OF SOUR WATER TANK

REHABILITATION FOR UK STEEL MILL GAS MAIN

OFFSHORE GAS TERMINAL – FUEL GAS KNOCKOUT VESSEL

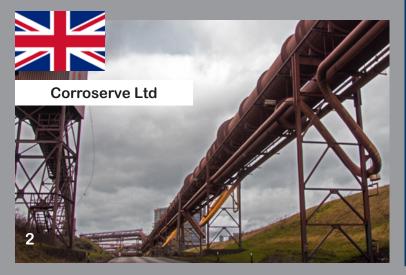
After first coat

The client wished to internally line the bottom section of the 2.7m diameter pipeline and accepted that due to the scale of the project, this had to be completed in stages. The challenge was to complete two sections of the main, a total length of approx. 575 m during a very short shutdown period.

Utilising its extensive project experience and skilled labour force, Corroserve successfully protected the pipeline with Polyglass VEF and are in an excellent position to work with the customer on the next phase of the main pipeline rehabilitation project.

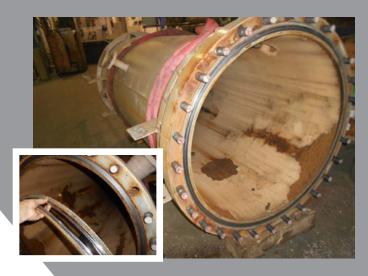
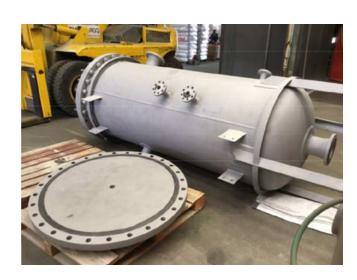
Corroserve offered a solution comprising: surface preparation, application of a Polyglass VEF coating system and surface testing. The nozzles and plate were pre-machined/rebated to prepare the faces for coating application. The internal substrate was then abrasive blasted to remove the existing coating system and prepare the surface, carried out to ISO 8501-1 SA $2\frac{1}{2}$ to achieve a minimum surface profile of $50\mu m$.

Polyglass VEF was specified for all internal surfaces - applied by hand and airless spray to achieve a minimum DFT of 1250µm. Spark testing ensured the coating was free from holidays and pin holes. The external surfaces were also abrasive blasted and two coats of Plasmet ZF applied with a final cosmetic topcoat of Corrothane AP1.

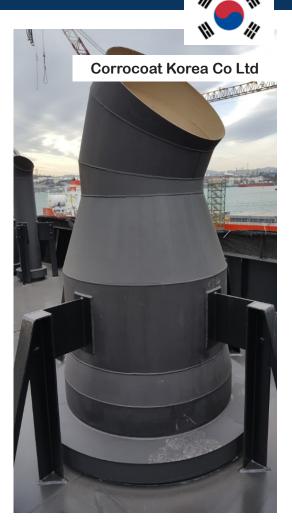
In order to demonstrate the beneficial properties of Polyglass VEF. Corrocoat Korea has used the material at 1,500um thickness on the internal surfaces of an exhaust gas outlet pipe at Hyundai Mipo Dockyard and is currently introducing the product to other shipyards.

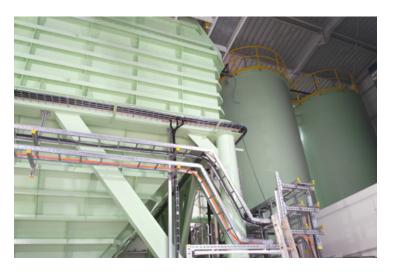
CorroTech in the Czech Republic has enjoyed great success on a contract to protect the internal surfaces of a lamella cleaner from corrosion and chemical attack within the waste water industry.

To prepare the substrate, internal surfaces were blast cleaned to provide a minimum surface profile of $50\mu m$. Polyglass VEF was applied by airless spray to achieve a minimum DFT of $500\mu m$. Polyglass VEF is ideal for this type of application as it provides superior corrosion, chemical protection and temperature resistance.

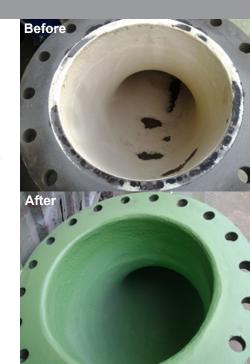
Black Point Power Station is located in the New Territories region of Hong Kong and is one of the world's largest gas-fired combined-cycle power stations. CorrocoatAsia, based in Hong Kong, were contracted to inspect, repair and recoat the internal surfaces of eight auxiliary cooling water pipes which are used to convey seawater from pumps to a heat exchanger. The pipes were coated with Polyglass 100 when they were first installed in 1996 and have been in constant use since then.

The pipe internals were sweep blast cleaned to highlight areas where the coating had been damaged and a single coat of Polyglass 100 applied directly to the prepared surface, at 850um DFT. It is testimony to the excellent properties of the coating that only after 21 years of application was it found necessary to carry out repairs.

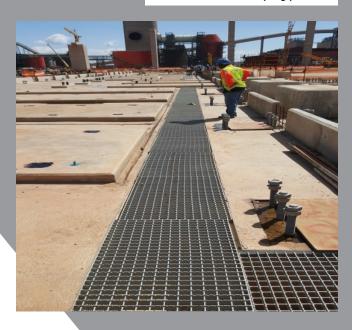
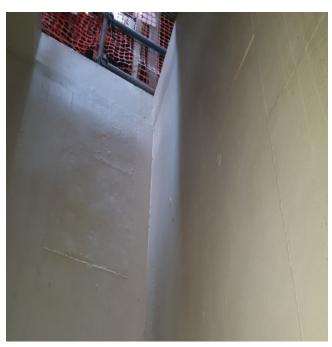
The scope of works included the supply of all linings, primers, glass cloth, abrasive blast equipment and materials, airless application equipment, temporary structures and all site management and labour necessary to professionally deliver, install, QC test & warrant all site linings. The substrate was new cast concrete with a minimum 30Mpa strength.

All concrete surfaces were abrasive blast cleaned to remove laitance and then thoroughly vacuumed to remove dust and spent abrasive. All the surfaces were primed with Corrocoat WCP to wet-out the surface and seal any concrete pores. Multi-directional woven-roving glass-fibre, saturated with L600 laminating resin was then applied to increase structural stability and limit any potential for shrinkage during curing. Finally, a coating of Polyglass VEF to a DFT of 1000 – 1500 µm. was applied.
