# CORROCOAT NEWS

February 2019

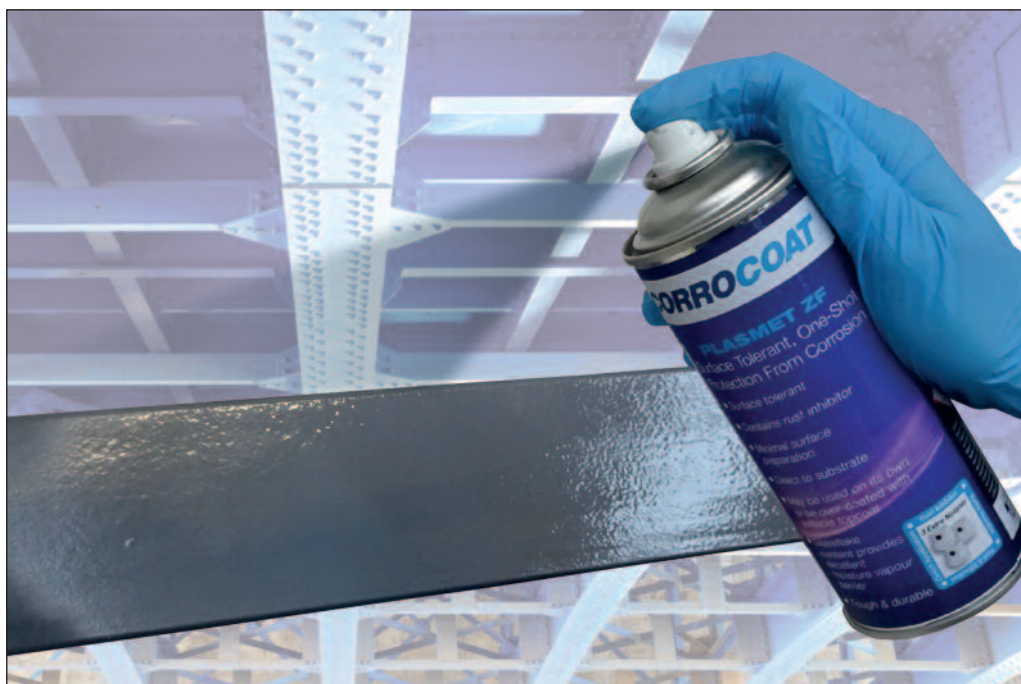
**We are pleased to announce the launch of an aerosol-delivered, high performance surface tolerant coating system.**

Supplied in convenient, easy-to-use, single pack 400ml aerosols, application is as simple as breaking the internal seal, shaking the contents and you're ready to go. There is no need for scales, mixing containers, mixers, cleaning solvents, brushes or spray equipment.

**Based on our proven Plasmert ZF materials, this new aerosol application technology contains a high performance**

**glassflake and MIO filled two-pack epoxy, with both passivating and rust conversion properties.**

With a useable life of many hours and free, easy to change additional nozzles with each kit, the Plasmert ZF aerosol offers a tough durable coating ideally suited for small areas of coating damage, rust spotting, small areas of corrosion damage, repairs where a coating has been removed for inspection and many more.

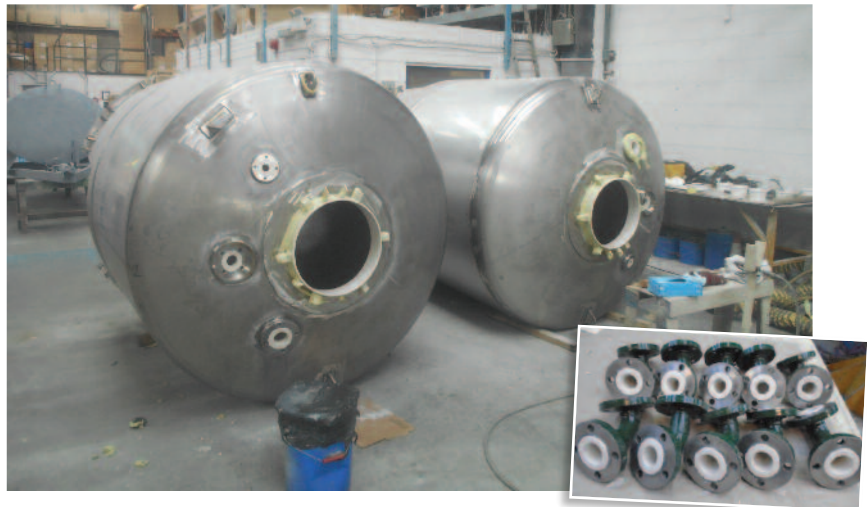
- Machined surfaces were masked and protected prior to abrasive blast cleaning in accordance with ISO 8501-1 Sa 2 ½ to achieve a surface profile of 50µm.

- After a final blow down the vessels were vacuumed to remove all dust and debris.
- A first coat of AR4 was applied by airless spray to an average wet film thickness of 600-800µm followed by a second coat to achieve the specified minimum DFT of 1250µm.
- The coating was thickness tested and spark tested to ensure it was free from holidays and pin holes and then left to post-cure at 60-80°C for 8 hours to provide the best chemical resistance.

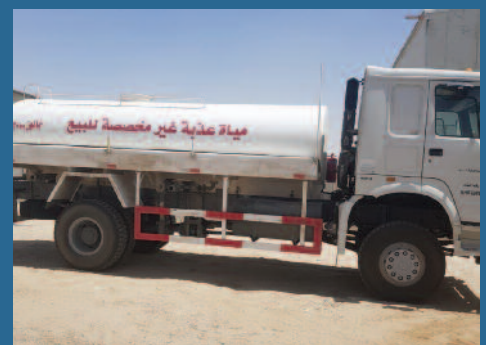
Al Sabaiea successfully quoted for a contract for the Drilling and Oil Well Maintenance Company to refurbish and corrosion protect the internal surface of a 10,000 litre potable water tanker.

The internal surface of the tank was abrasive blast cleaned to Sa2½ to provide a surface profile of 50µm before Corrofill was applied to areas where pitting was revealed and then Polyglass 100 was applied by airless spray.

The contract was completed by a four-man team in just six days and the tanker delivered back to the customer who provided excellent feedback on a job well done, to budget and on time.

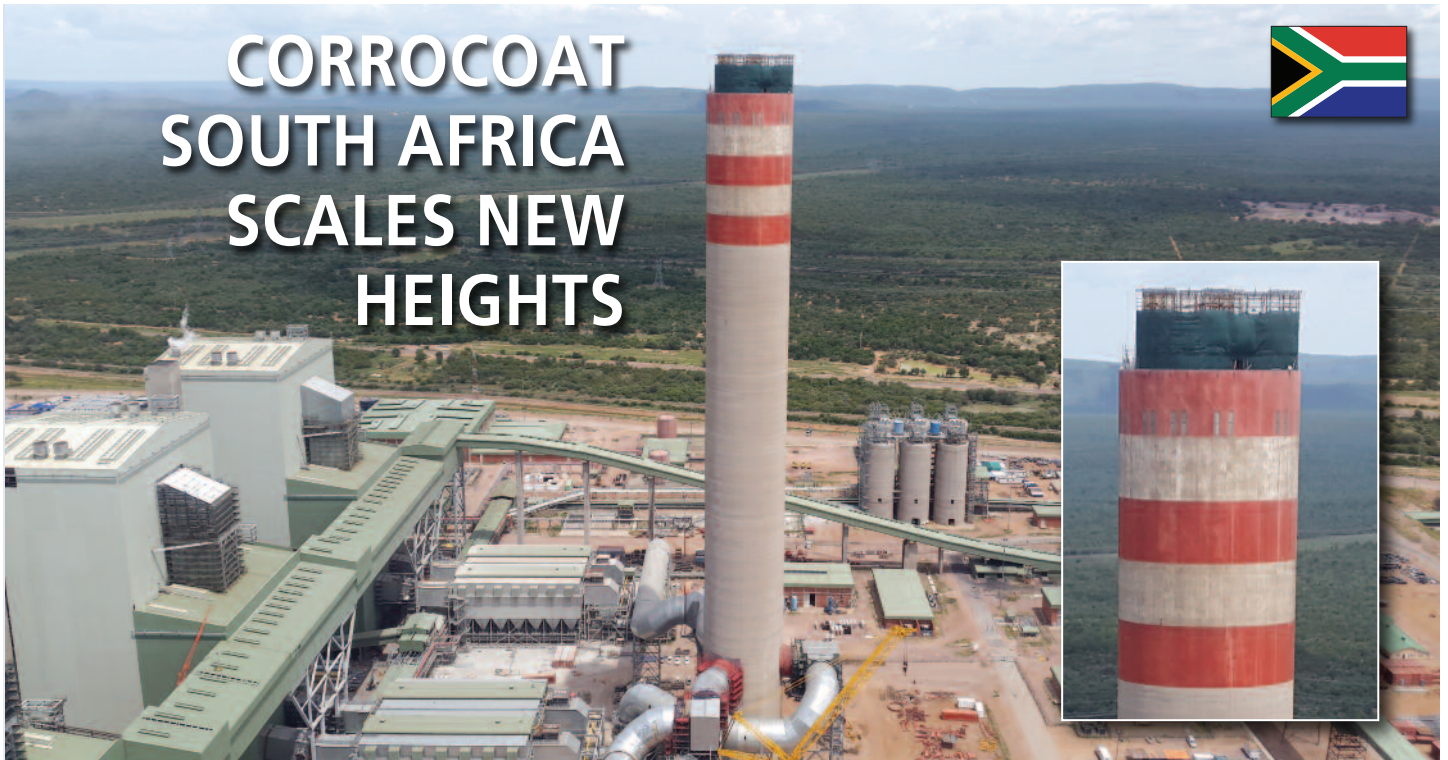
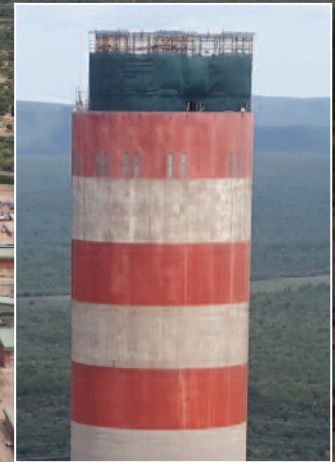
**When Corrocoat SA was approached by Eskom Medupi Power Station – one of the world’s largest coal fired power plants - to provide corrosion protection for six stainless steel flue cans, they realised that this would be a major challenge. The cans were located at the top of Eskom’s chimney stacks, so all the work would have to be carried out 220m above ground.**

Their solution in this oxygen depleted environment where temperatures could reach 120°C., was based on the use of Corrothane XT, which offers outstanding chemical resistance coupled with continuous protection at high operating temperatures. For the cooler external surfaces POLYGLASS VE was recommended

- 6 x 9m diameter flue cans to be protected with a total surface area of 2,640m<sup>2</sup>.
- 800 litres of Corrothane XT and XTHA plus 3000 litres of Polyglass VE and VEHA used to complete the work.
- 130 tonnes of abrasive blast media used – all of which had to be carried up to the top of the stacks, along with 3 x blast cleaning machines, air receivers and attendant air and blast hose, nozzles, PPE etc.
- All equipment and materials were winched to the top of the stacks and conveyed using either a ratchet-type ‘Torga’ elevator which took a minimum of 20 minutes to reach the top – or one hour each way by foot!
- 700 linear metres of sharp edges to grind and radius on the stainless steel substrate.
- 1300 linear metres of stripe coating hand applied.

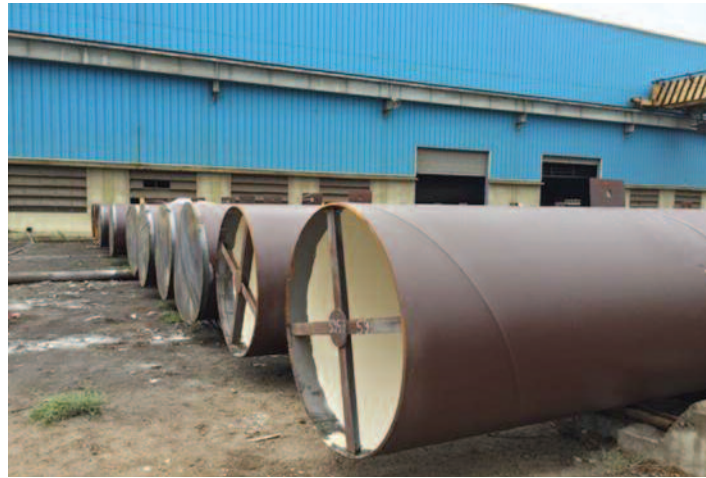
KCPL, was asked to protect 1.3m and 1.5m diameter cold water inlet and outlet pipes for the Tangedco Ennore Power Project in South India. Polyglass 100, a coating developed specifically for immersed marine conditions, was specified to provide protection against the seawater the pipes would be carrying when installed. The work was to be completed at several of the pipe manufacturer's facilities right across India so the project proved to be a test of KCPL's organising and scheduling skills.

The internal surfaces of the pipes were abrasive blast cleaned to Sa2½ before Polyglass 100 was applied in multiple coats to achieve a DFT of 1000µm. The pipes were then welded together and erected on site in their final positions where KCPL coated the joints - again with Polyglass 100.

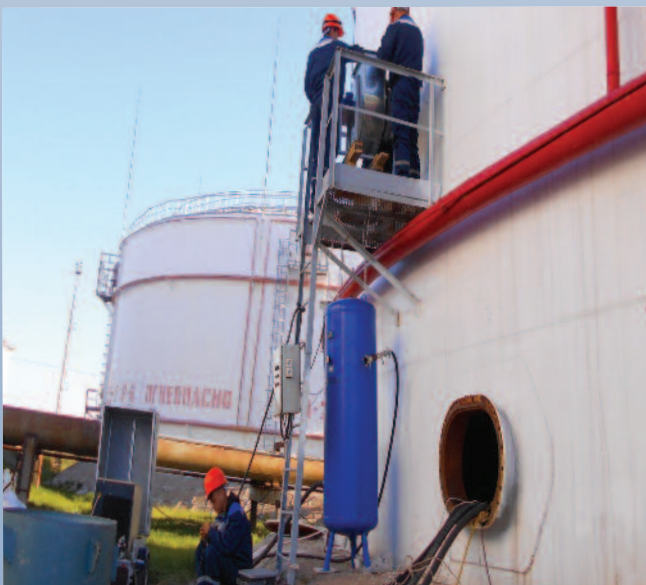
**Kirloskar Corrocoat Private Ltd (KCPL) has been operating in India since 1993 using Corrocoat coating systems to protect all manner of infrastructure and assets in many industry sectors.**

The project was completed over a period of six months involving a team of 20 personnel. In total a surface area of some 51,100 m<sup>2</sup> was corrosion protected- quite an achievement.

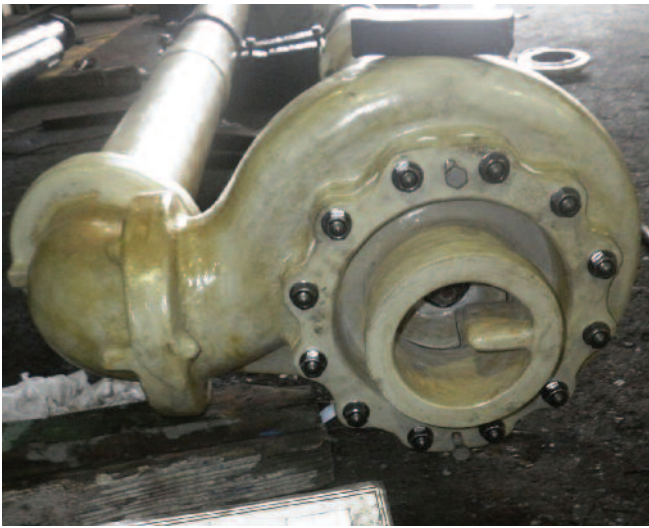
**Corrocoat Japan was asked to service a raw water pump that they last serviced in 2011. At that time the vertical wet-pit volute pump had been in operation since 1993 without any servicing and as a result all the internal components were found to have deteriorated. A full refurbishment was carried out and the pump returned to service.**

When examined, the pump was found to have deformed impeller blades and in general all the internal components were suffering abrasion and corrosion damage so a full refurbishment was required.

The pump was transported to Corrocoat Japan's workshop where it was stripped and abrasive blast cleaned. The impeller was repaired with wetted out glass fibre cloth and coated with Corroglass 600 Series which was also used on the internals of the casing as required. Both impeller and casing were then coated with Polyglass VEHA which provides excellent resistance to solvents and acids at elevated temperatures and provides excellent undercutting resistance and sliding abrasion resistance.

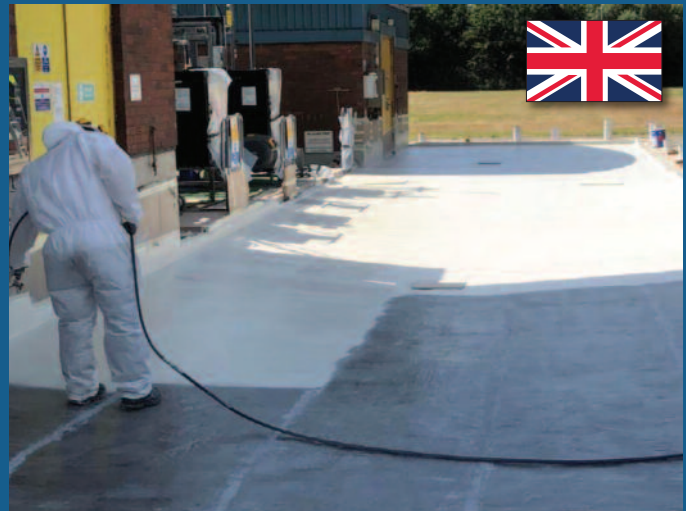
Corrosolve was invited by a UK power station to inspect a loading bay floor that was experiencing attack due to its aggressive chemical environment. The concrete surface had been badly damaged and required repair and protection from further attack – a level of protection not achievable with standard concrete materials. A Corrosolve NACE inspector recommended a complete refurbishment programme involving the application of specialist materials and Corrocoat coatings.

The concrete surface was sealed using WCP to ensure no moisture could penetrate the new coating system from below and Corrofill VE was used to fill holes and cracks to ensure an even surface for the final coating. The full floor area was then laminated using multi-axial glass fabric thoroughly wetted with L600 laminate resin to provide

structural strength. The glass fabric was rolled into place to ensure full adhesion and to remove any trapped air. Two coats of Polyglass VEF were then applied by airless spray to achieve a total WFT of 1250µm, quartz aggregate was incorporated into the second coat to give an anti-slip finish.

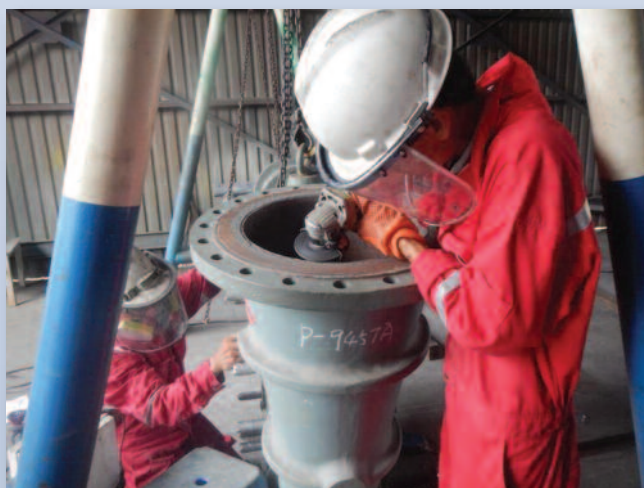
After conducting an on-site assessment survey and talking all necessary measurements, the pumps and impellers were transported to the VGCE workshop, where they were dismantled and cleaned to remove any contaminants.

The flanges were rebated to protect against crevice corrosion and the flanges and shafts protected before being abrasive blast cleaned. Corrofill E was used to build up the vanes of the impellers after which laminating resin and multi directional glass fibre matting was used to add improved strength to the blades. Plasmert HTE was applied at 3000µm dft, before a final coat of Plasmert EP1 completed the refurbishment work.

Plasmert WR was used to bring the back plate & suction housing back to original size and shape and Plasmert HTE provided protection from chemical attack and abrasion. The same material was also used to provide a protective coating on the internals of the casing.
