## A message from our CEO & Technical Director

### Also in this issue...

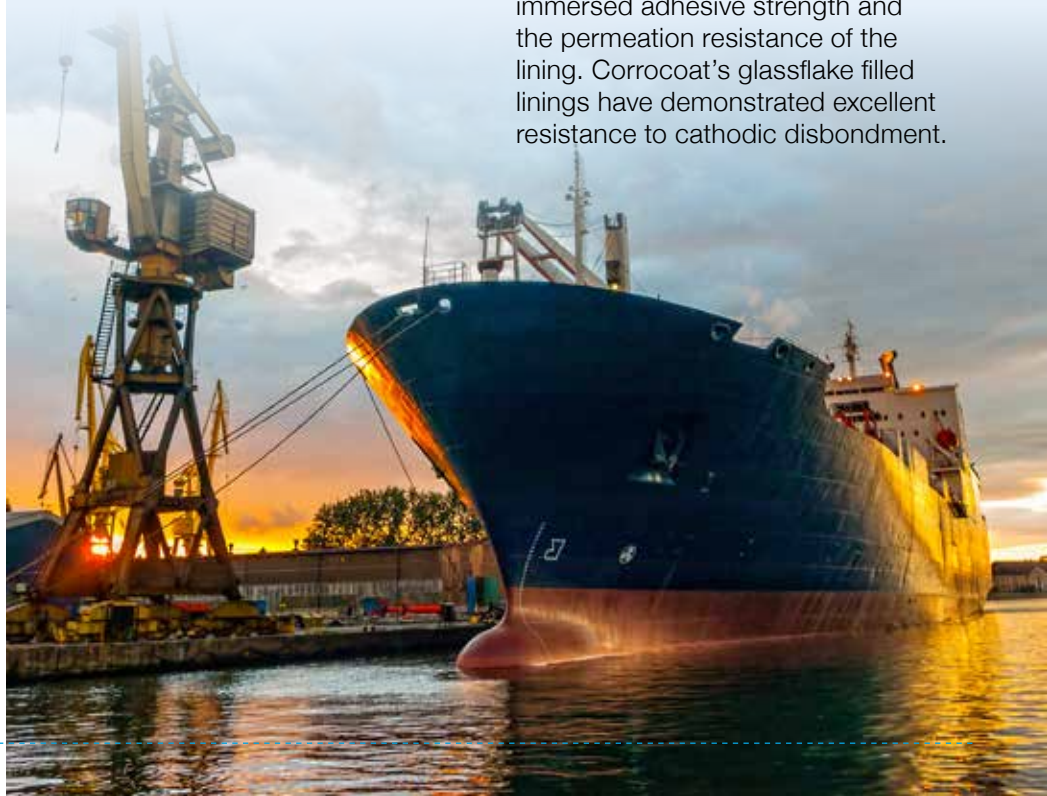
Metal substrates are sometimes protected from corrosion using Impressed current or sacrificial anodes. Cathodic disbondment is disbondment or delamination at a damage site, caused by the passage of the resultant voltage. Water is electrolysed to form hydroxyl ions at the substrate and on some coatings significant delamination can occur.

Cathodic disbondment testing can be assessed in the laboratory, most commonly by applying a known voltage across a plate with an artificial defect, for a specified test period. There are various test methods used. The resistance of coatings to disbondment is a key factor in many applications and the ability to resist this effect, is closely related to the immersed adhesive strength and the permeation resistance of the lining. Corrocoat's glassflake filled linings have demonstrated excellent resistance to cathodic disbondment.

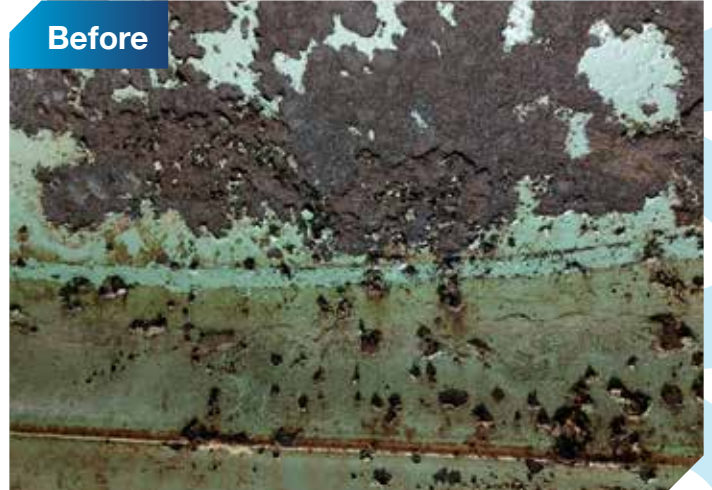
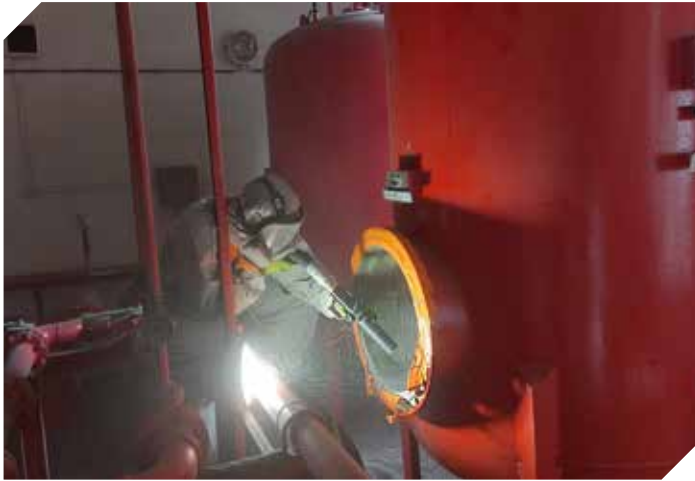
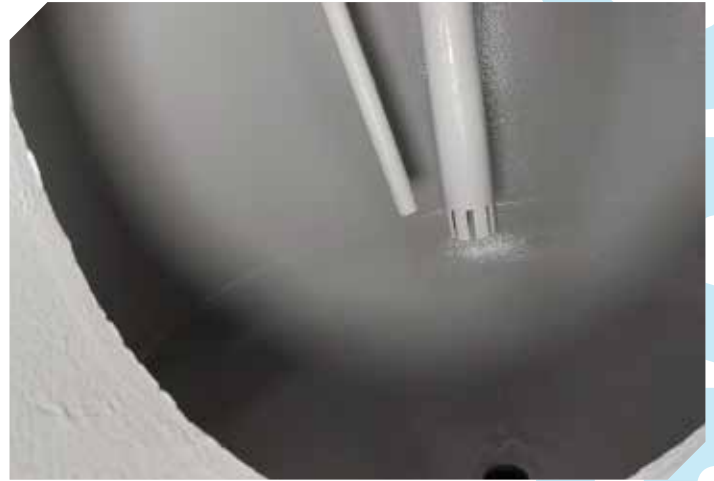
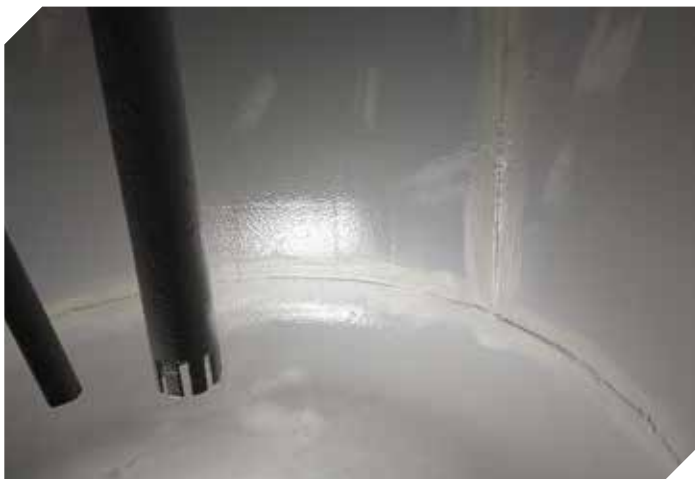
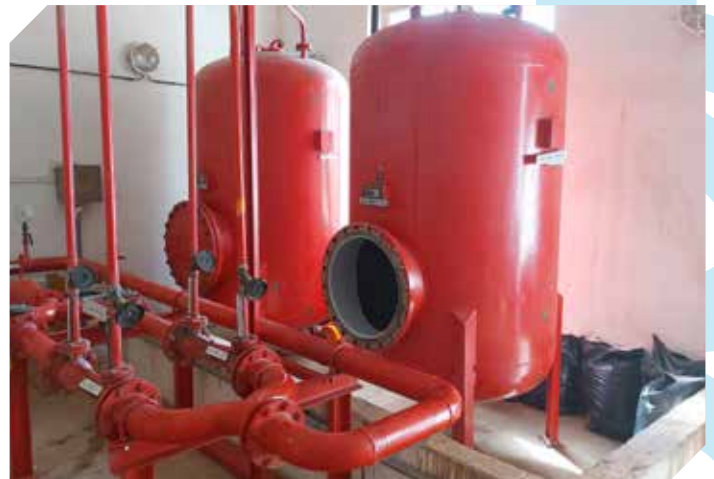
The tanks stored a fire foam concentrate which had caused damage to the existing internal lining resulting in pitting corrosion. The Corrotech team carried out the work in-situ at the Nuclear Power Station and began by removing all of the existing deposits & paint before decontaminating the surface from soluble salts.

Following abrasive blasting, the team discovered a number of sharp edges and poor quality welds, which needed to be mechanically repaired ahead of the coating system being applied.

The coating selected for this job was Corrocoat Zip E, an epoxy glassflake coating offering durable protection in aggressive service conditions – ideal for the long term protection of the internal substrates of these fire foam tanks.

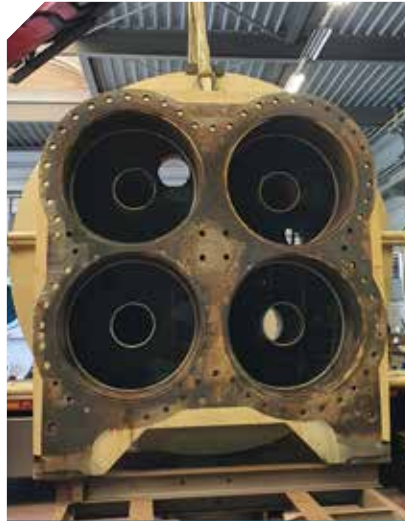
Following 8 years in service, the epoxy coating in the internal cooling water area became detached, causing a leakage in the cooling water area of the air section. Unbeknownst to the team, the housing unit weighed an enormous 13 ton and upon arrival to the workshop presented a logistical challenge getting the unit offloaded and ready to begin the repair work. The overhead crane onsite was only capable of lifting 6 ton, so the team arranged for a mobile crane to move the housing unit. With a tight schedule of just two weeks given to complete the work, the coating team didn't disappoint, working around the clock to ensure that the job was completed to the client's satisfaction.

**Cooling water area before protective coating**

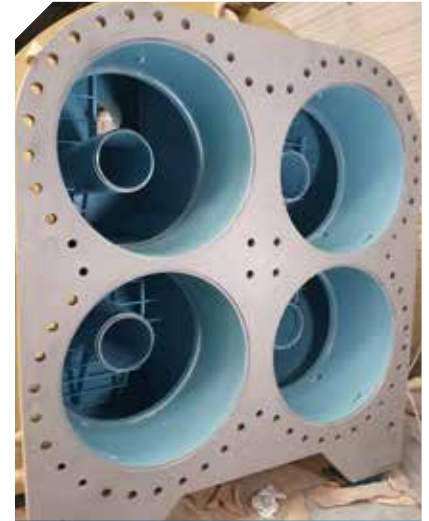
**Cooling water area following protective coating**

The team sandblasted the housing internal and external before applying the Corroglass 600 series internally, with the externals being coated with Plasmest ZF and a top coat of AP1.

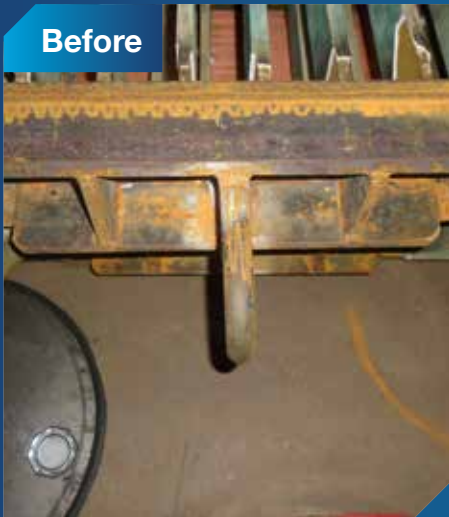
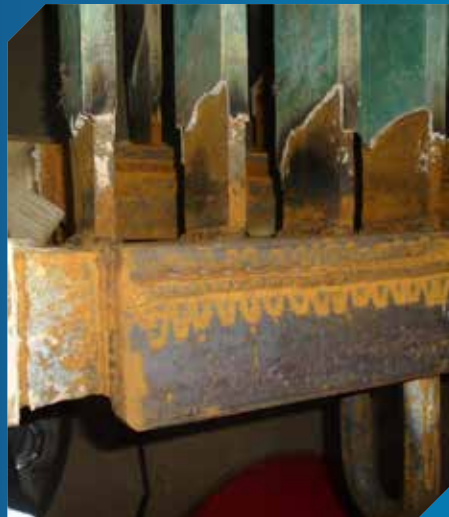
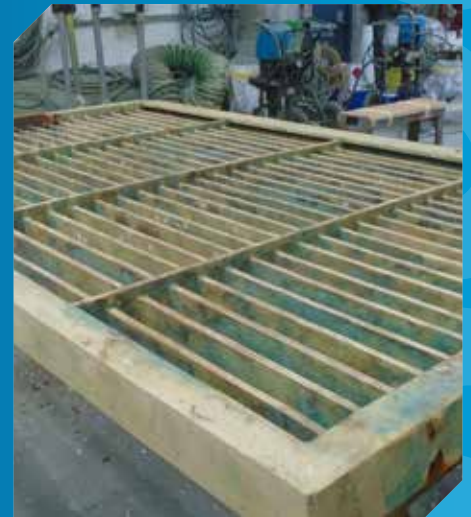
Before

A leading energy company in the UK recently required refurbishment of two jetty intake screens. The screens had been in service for approximately 12 years and had suffered mechanical damage. The client had also welded on new lifting points which required protection and coating repair. They had previously needed to take out the screens and manually remove the marine growth which restricted the water flow into the cooling water system, reducing the efficiency of the condenser, which could impact the power generated from the station.

Upon arrival to the workshop the screens were flash blasted to reveal the true extent of the damage and in turn the repair required.

Surface preparation then followed on the carbon steel substrate and on the new lifting lug area. Following cleaning to prepare the surface ahead of coating, Corroglass 600 Series was then used to achieve a minimum DFT of 900 microns, with the appropriate thickness and spark tests being completed following adequate cure.

Biofoul was applied via airless spray, as a topcoat to achieve a minimum DFT of 300 microns. Biofoul was selected as it has excellent long term fouling resistance and will resist flow velocities of up to 25m/s. The coating contains metallic copper and no fillers which are classified as toxic, such as TBT and some copper salt materials.

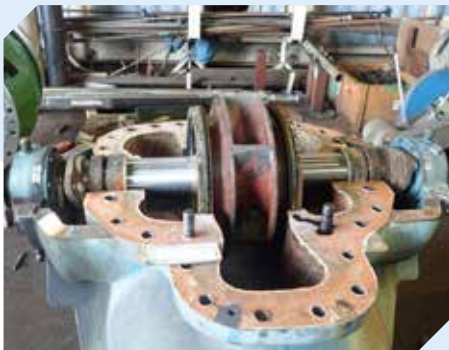
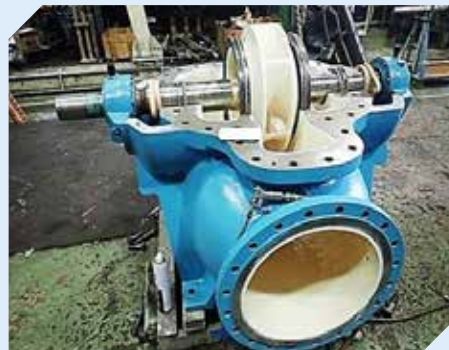
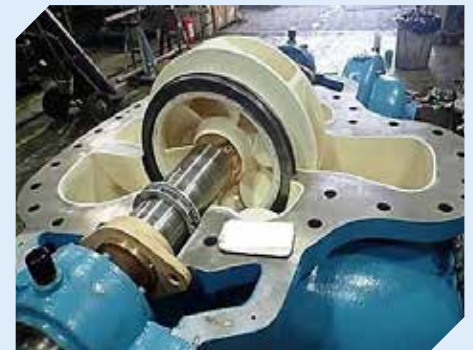
**Corrocoat Japan worked with a client in the Chemical Industry to assist them with saving energy by targeting the double suction pump of a cooling tower pump, which had been in service since 1986. The pump had long operating times and relatively large power loads and the aim of the project was to carry out maintenance to improve the overall energy efficiency.**

The pump was disassembled and any worn or defective parts were repaired or replaced. The internals were then coated with Fluiglide and the externals with Corroglass 200.

The team confirmed an impressive energy saving value of 9.2%, which was the equivalent to 35.16 kw/h, significant to 281,280 kWh/year. A fantastic result leading to a reduction in operating costs and the large power consumption for the client, alongside the necessity of recovering the original pump efficiency to improve the overall cooling performance system.

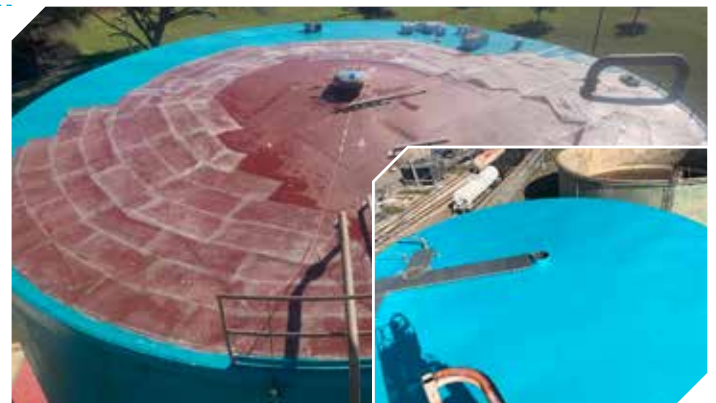
Three months after completion, the client found that the contractor had blasted hundreds of holes in the roof of the tank and had coated over them. This allowed rainwater to contaminate the contents of the tank. When confronted, the contractor advised that their scope of work did not include filling holes. In desperate need of a solution, the client turned to Corrocoat USA.

The team in the US vapour blasted the existing coating to achieve a commercial blast consistent with SSPC SP6.

The surface was then primed with Plasmet ZF (red) ahead of using Epoxy Laminating Resin and quadriaxial fiberglass mat to laminate a composite fiberglass layer across the entire tank roof. The team then chose a suitable polyurethane topcoat to offer UV protection in a colour that matched the remainder of the tank. The client was extremely impressed with the final result and the quality assurance and will continue to work with Corrocoat US on future projects.

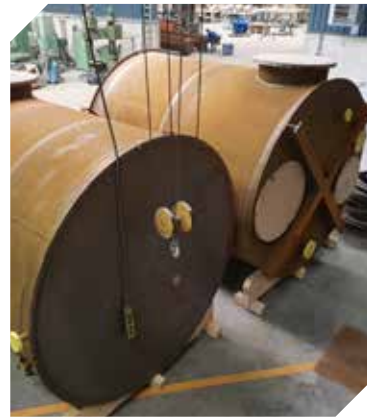
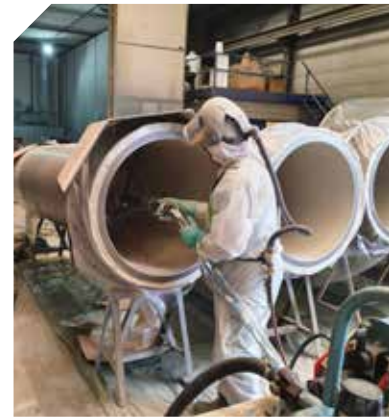
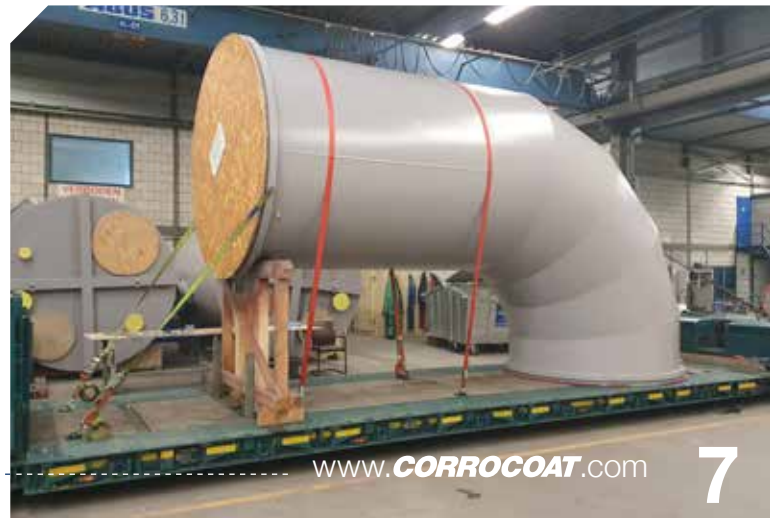
Our partners at Corrocoat Benelux won a contact with a client specialising in the construction industry to coat ten new large bore pipes and four cooling water tanks, including the tank inserts.

The equipment was destined for a large salt plant in Europe, where the pipes would be used to transport brine and the tanks would be used to store cooling water. The internals of the pipe pieces and tanks were coated with Polyglass VEF at a minimum thickness of 1200µm and a general paint system at a thickness of 340-400µm was used for the externals.

Due to the large size of the pipe pieces and tanks, overhead cranes, a forklift truck and a lorry were used to transport the equipment throughout the workshop for the work to be carried out, whilst a pipe sprayer was used to apply the coating on the inside of pipes and ensure an even layer of coating.
